Nepal After the earthquake

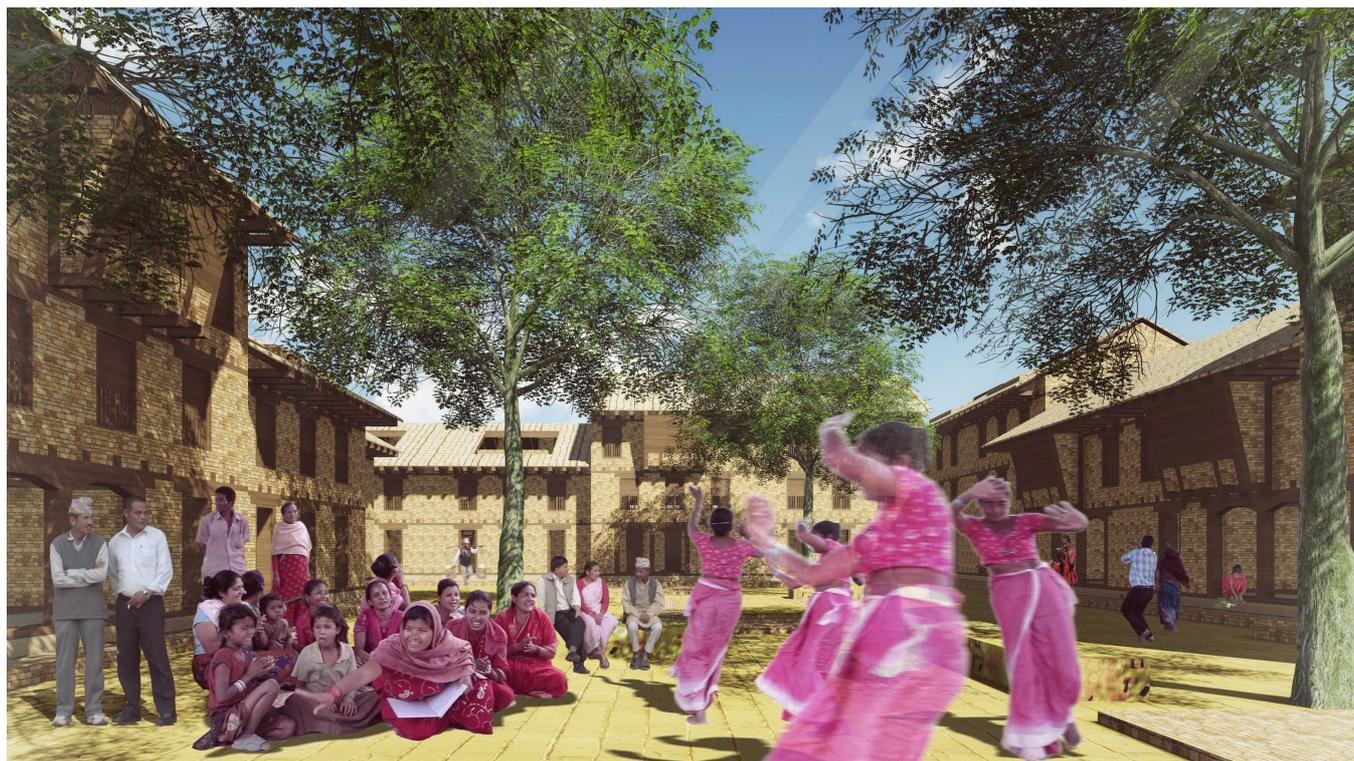
▽ *A render of how the village could look like after the reconstruction, based on the existing traditional Nevari courtyards.*

In **Tauchel** and **Mechchagaon**, 70% of houses collapsed. We visited old houses and analyzed the structures to try to find low-cost housing solutions using local materials and local artisans to enrich the heritage settlement. We found that old Nevari architecture, known for its interconnected courtyards, can be rebuilt and retrofitted to improve

We used existing community maps to organize where construction was needed in the village to preserve their cultural heritage, and started to re-plan the settlements around the existing courtyards and houses. Lumanti will continue the community planning process in these two towns.
